## Safety Inspection Report

### The Rype

Lydd Town Council

22 August 2023

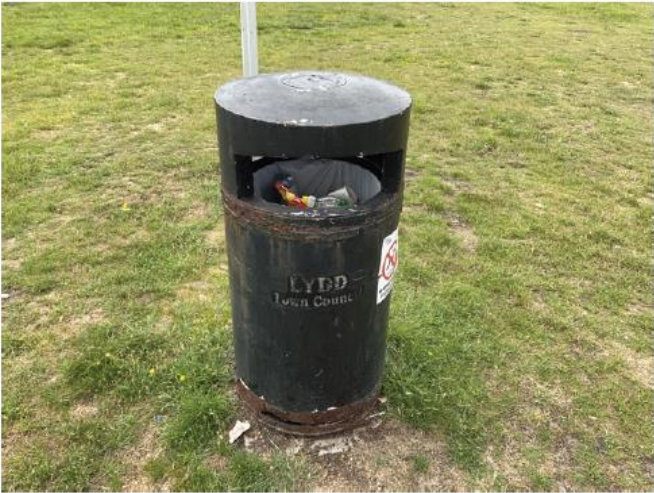
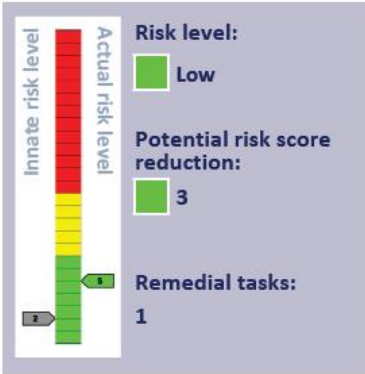
Litter Bin

Paintwork is in poor condition.

Consider replacing.

De-scale back to good base material and coat with lead free paint, using appropriate precautions. Repairs may be necessary where corrosion is severe.

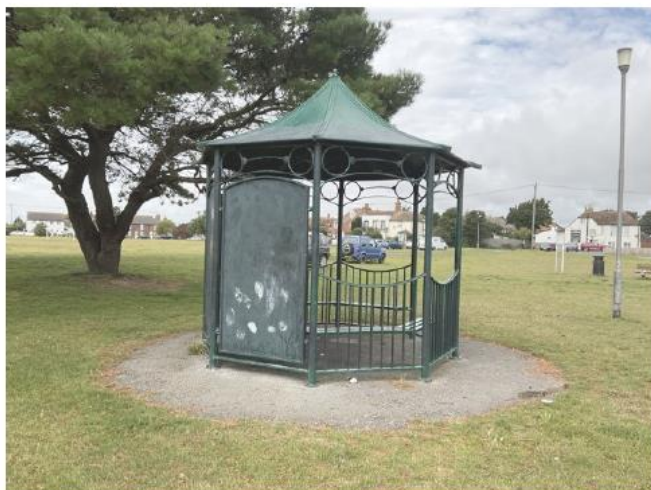
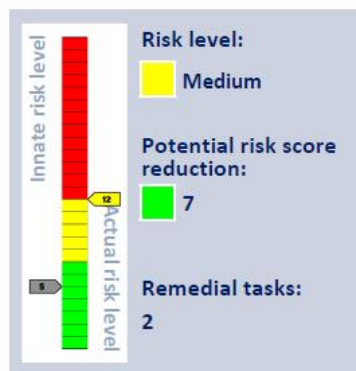
## Shelter - With Seating

Cap missing.

Replace.

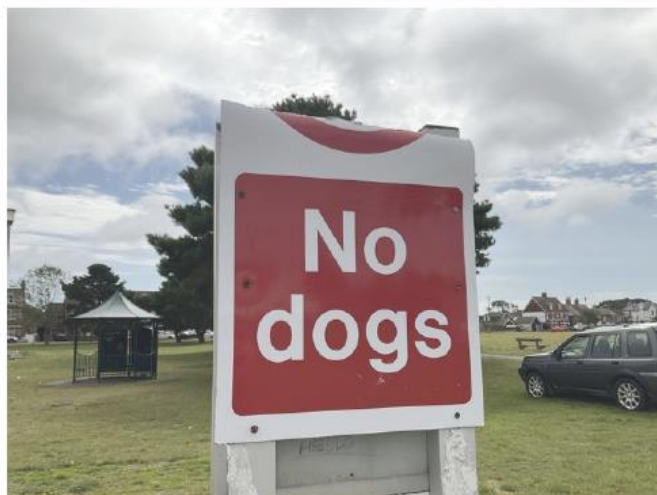
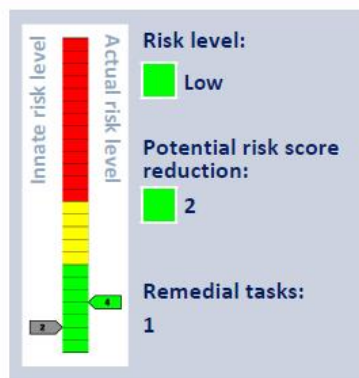
## Signage

Dog ban & ownership signs recommended.

The dog exclusion is not well signposted. Install an appropriate fence and provide suitable signage at the entrances.

See <https://www.rospe.com/play-safety/advice/signs>

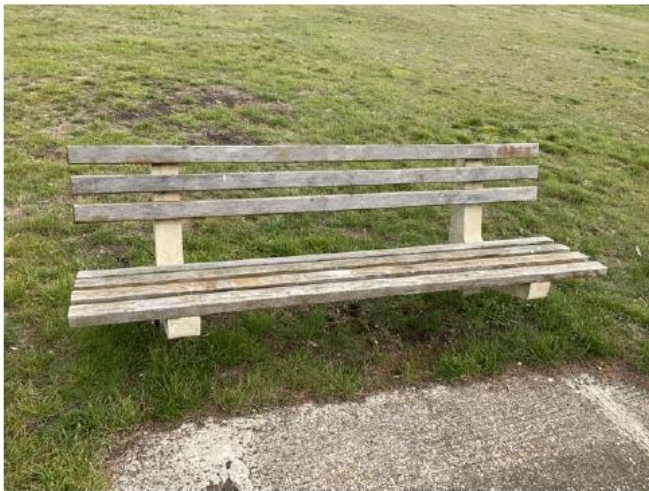
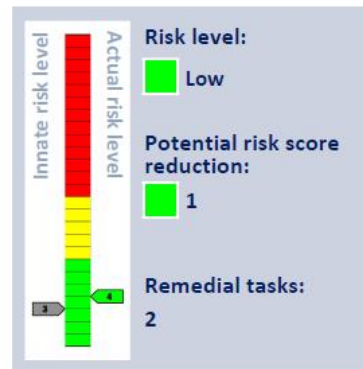
## Seating - Benches x 3

Bolt(s) loose.

Tighten.

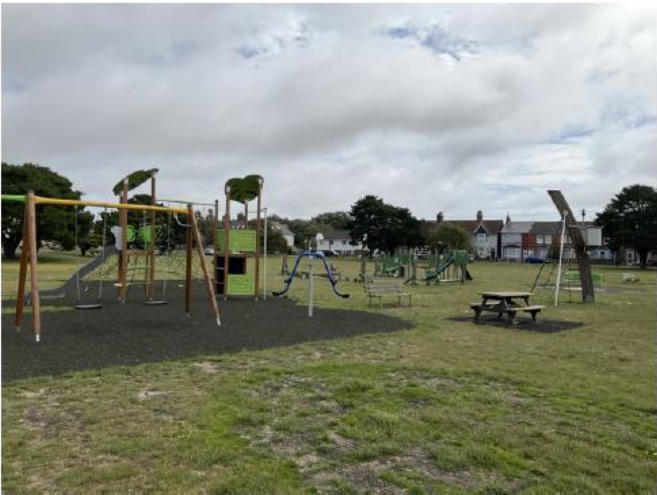
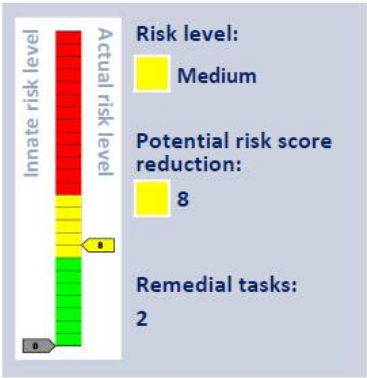
The Overall Site

As discussed, the inspector recommends enforcing a dog ban and installing appropriate fencing. Fencing will help to control the movement of young users and reduce the likelihood of vandalism. It will also help to potential reduce issues with dogs.

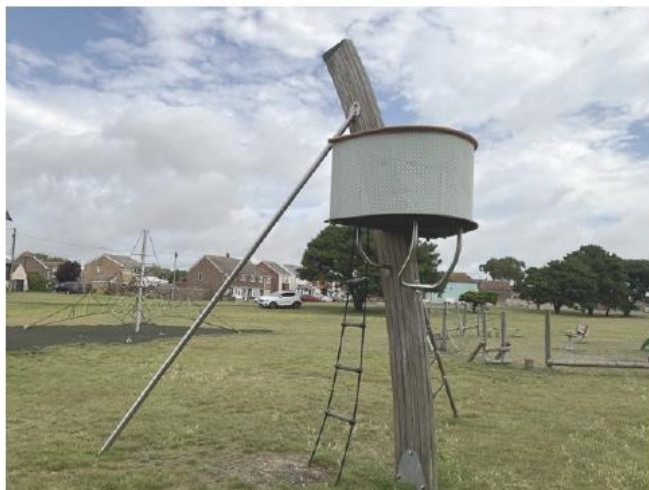
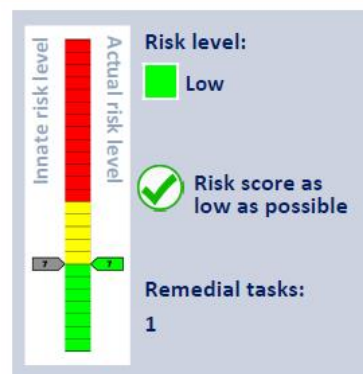
## Climber - Crow's Nest

Item is cracked.

Laminate support. Monitor closely for stability.

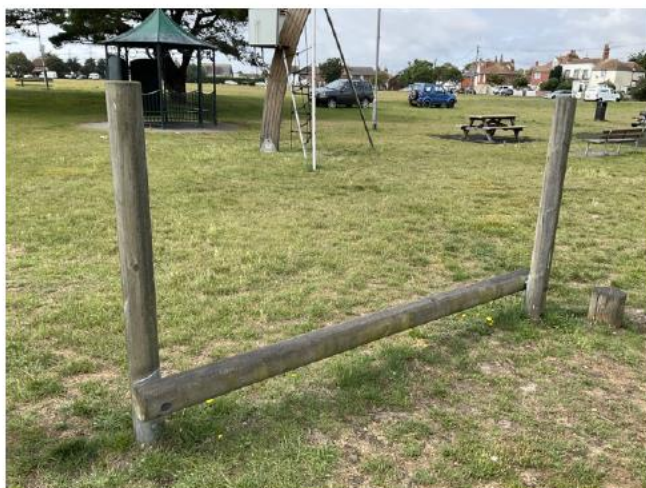
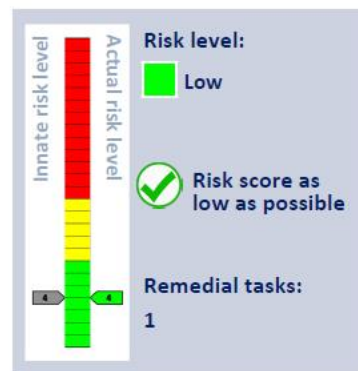
## Log Walk (With Supports)

Bolt(s) loose.

Tighten.

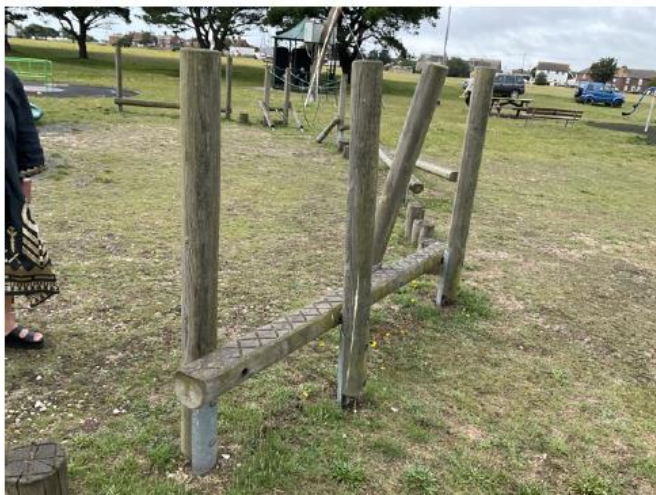
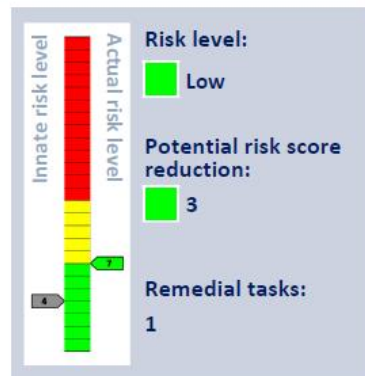
## Agility - Weave Beam

Fixtures loose or missing.

Tighten.

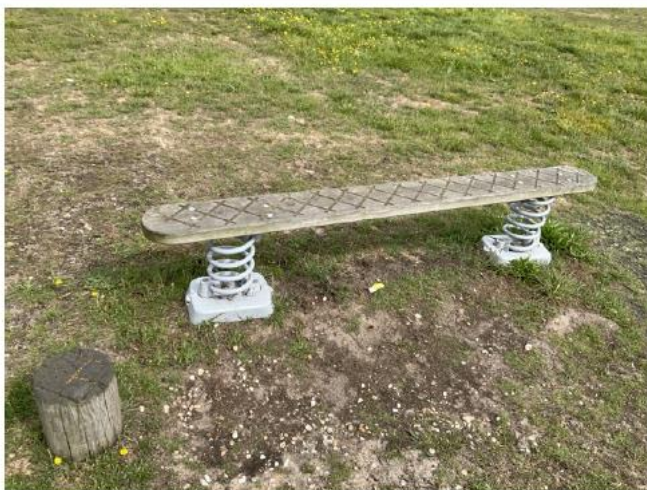
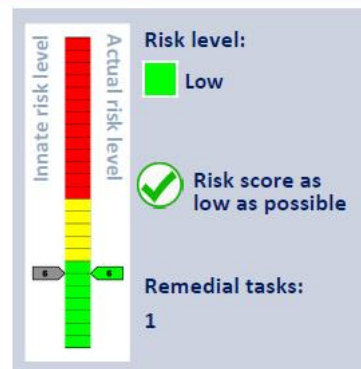
## Agility - Wobble Board

Item is damaged.

Replace.

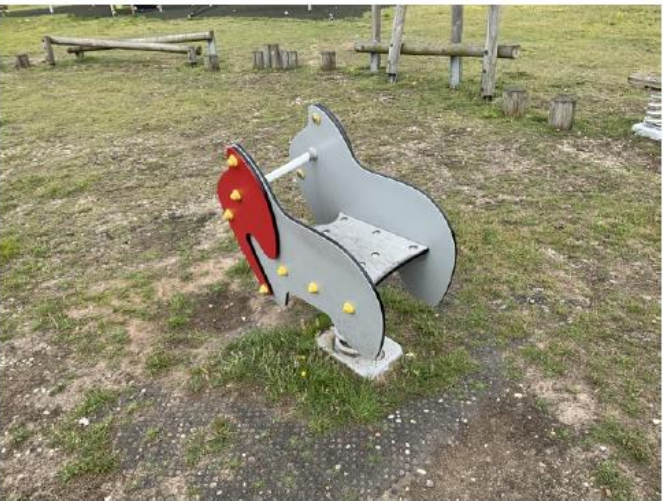
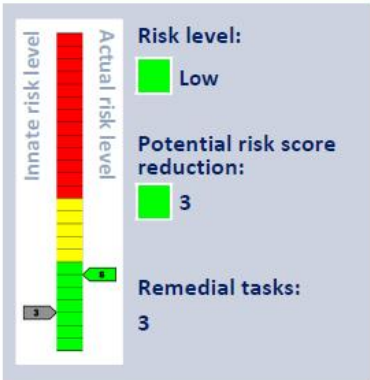
Rocker - Elephant

Cap missing.

Side fixing.

Replace.

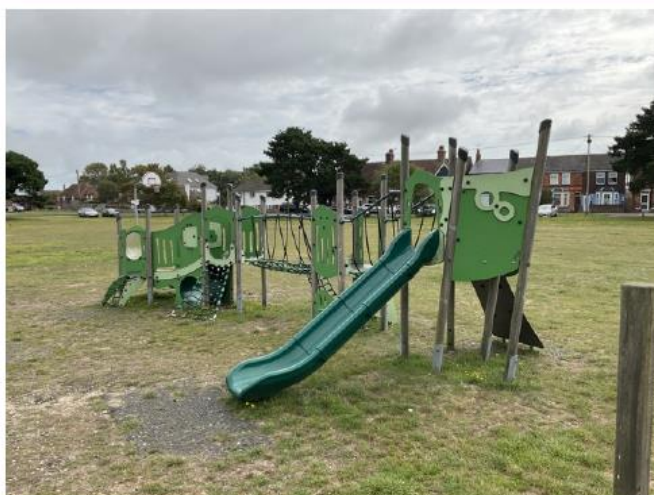
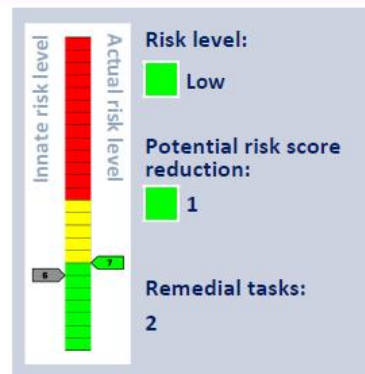
## Multiplay

Cap missing.

Above tunnel entrance.

Replace.

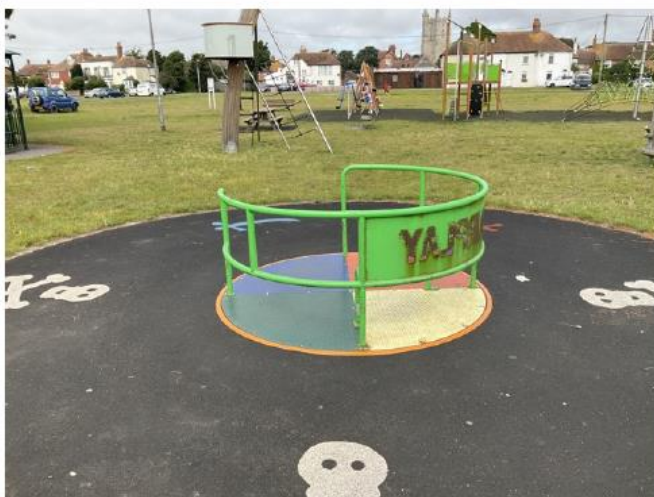
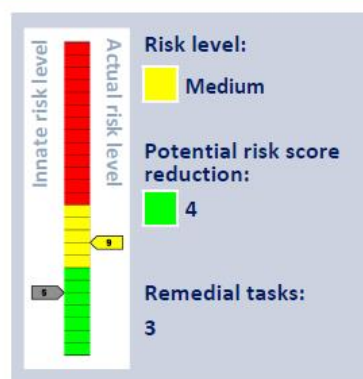
## Carousel - Accessible

The item complies with the requirements of the relevant standards.  
The surfacing is not compliant with the requirements of the relevant standards.

Bearings require service.

Monitor and replace when necessary.

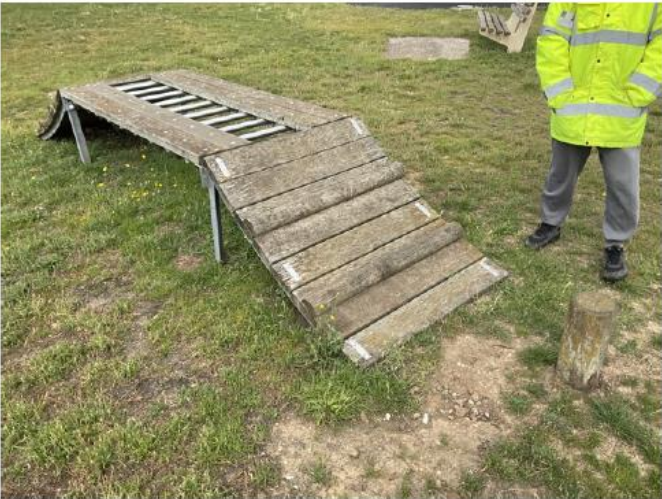
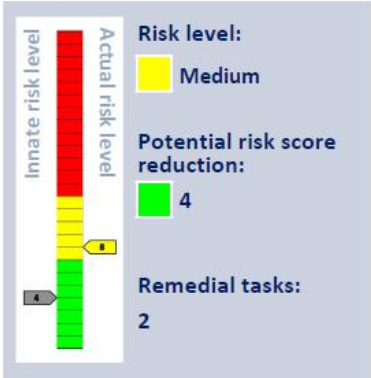
Bridge

Cap missing.

Replace.

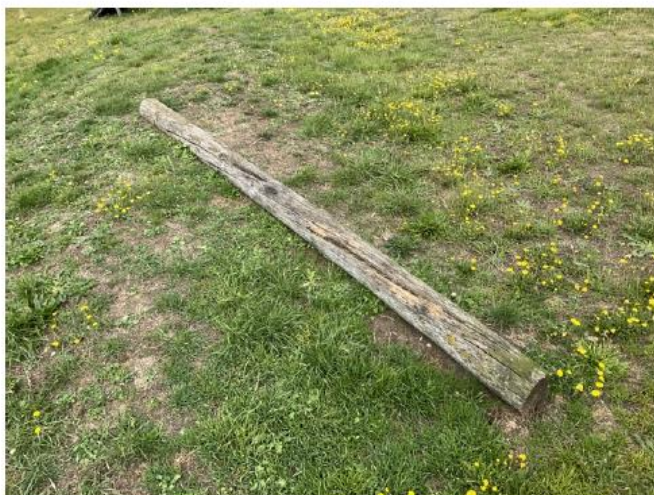
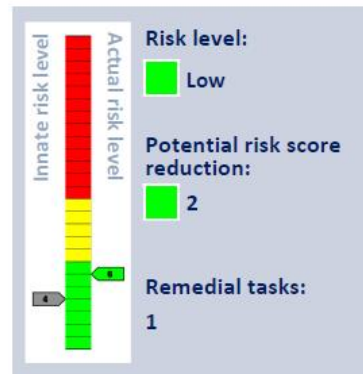
## Agility - Balance Beam

Timber is decayed.

Consider removal. Monitor hazards in the interim.

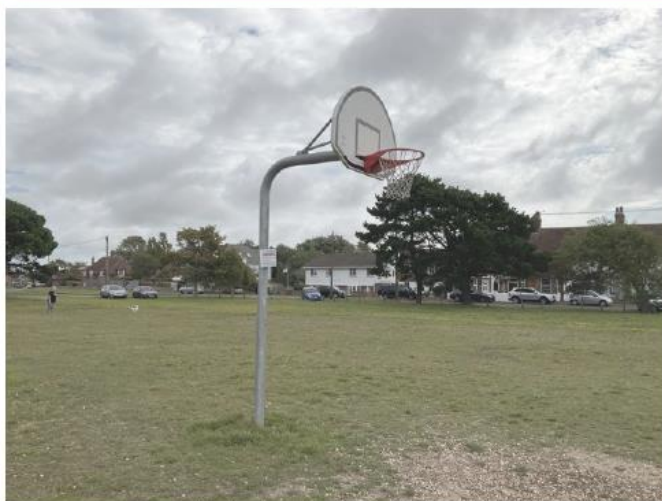
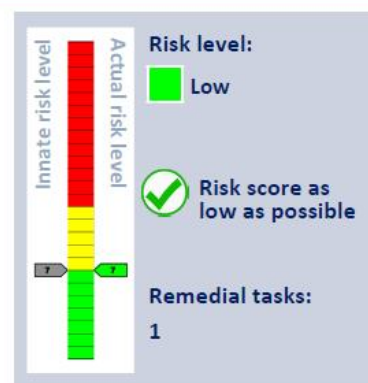
## Basketball Goal

Paintwork is in poor condition.

De-scale back to good base material and coat with lead free paint, using appropriate precautions. Repairs may be necessary where corrosion is severe.

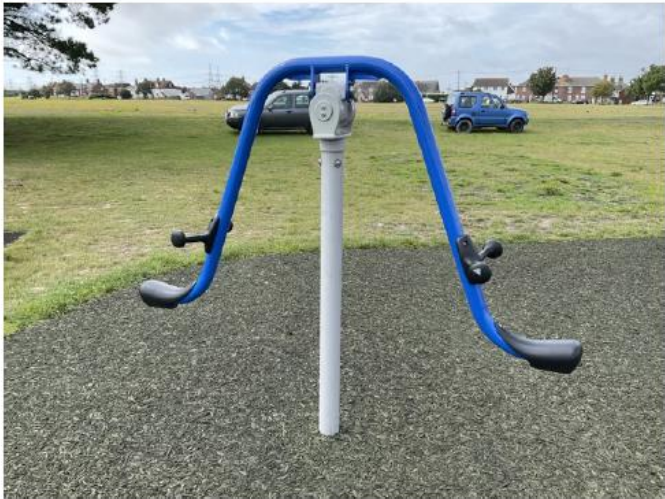
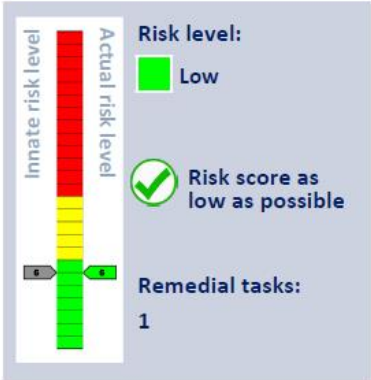
Rocker - Seesaw - Overhead

The supporting components should be dismantled and inspected according to the manufacturer's instructions. This will need doing on a regular basis, as defined by the manufacturer. This can lead to a high risk if no action is taken.

Asset very stiff to rotate. Refer to manufacturer.

Dismantle and inspect according to manufacturer's instructions.

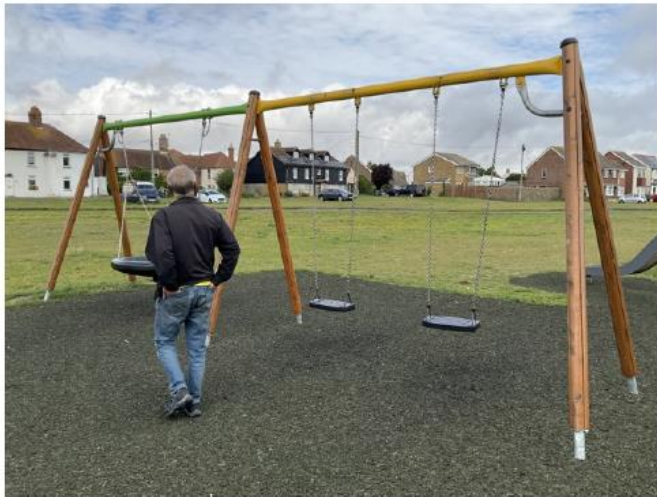
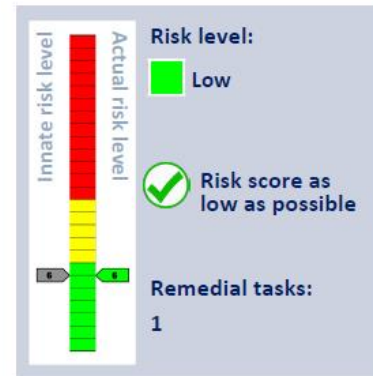
## Swing - Mixed - 2 Bay 1 Basket 2 Junior Seat

Paintwork is in poor condition.

De-scale back to good base material and coat with lead free paint, using appropriate precautions. Repairs may be necessary where corrosion is severe.
