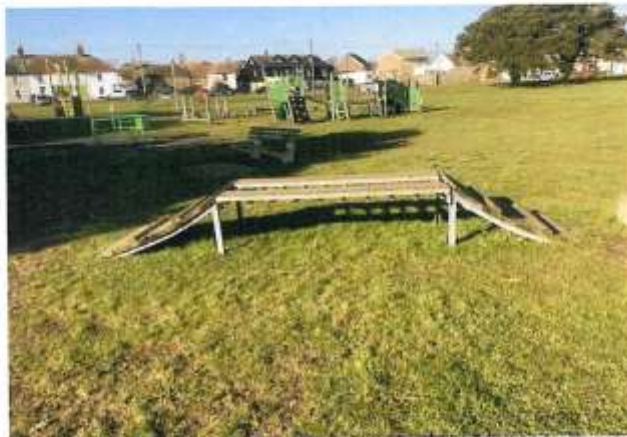
## Agility - Bridge

Cap missing.

Various on underside.

Timber is decayed.

Replace.

Replace affected parts.

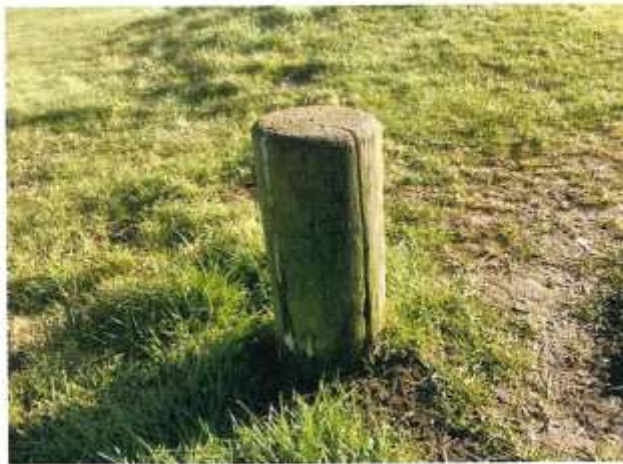
## Agility - Stepping Log

Timber is decayed.

Remove and make the ground level.

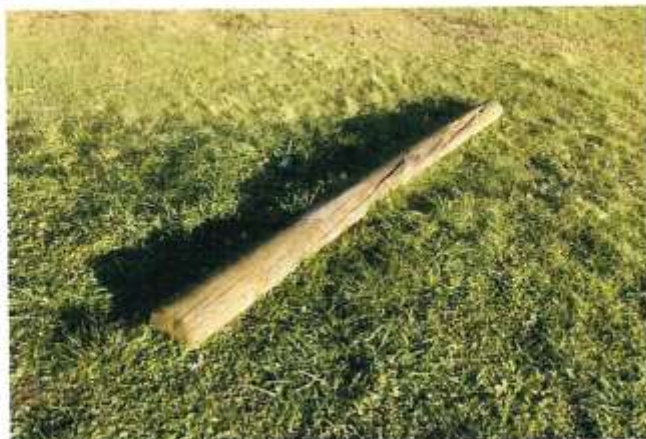
## Agility - Balance Log

Timber is decayed.

Check on a routine basis.

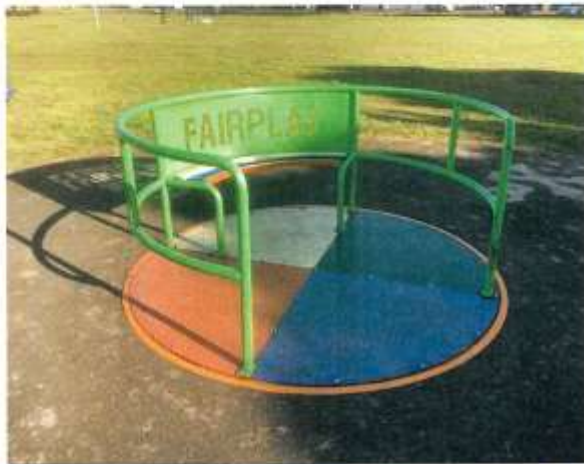
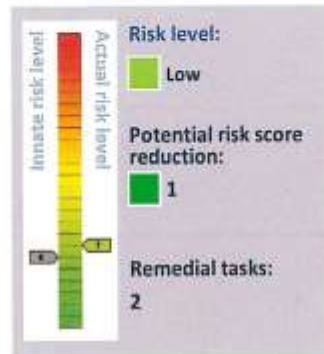
## Carousel - Flush

The item complies with the requirements of the relevant standards.  
The surfacing is not compliant with the requirements of the relevant standards.

There is wear in the bearings.

Some bearing wear, but the asset is operating fairly smoothly at the time of inspection. The rate of wear will depend upon the level of use. Monitor.

Insufficient protective surfacing extent has been provided.

Depth measured as 20 mm, with concrete beneath. The surface should provide adequate impact attenuation for a free height of fall of 1 m. The inspector considers it to be unlikely that the surface will provide this. Monitor, plan to replace this asset and its surfacing.

Monitor and replace when necessary.

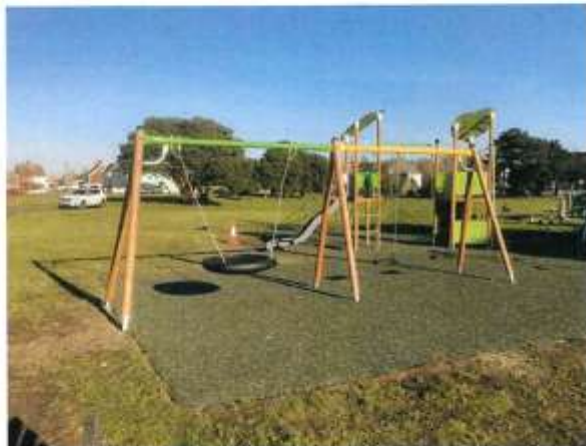
## Swing - Junior - 2 Bay 3 Seat

Fixtures loose or missing.

The indicated bolt was left finger tight only. Ensure that all other bolts have been properly tightened in accordance with the manufacturer's instructions.

Tighten/replace.

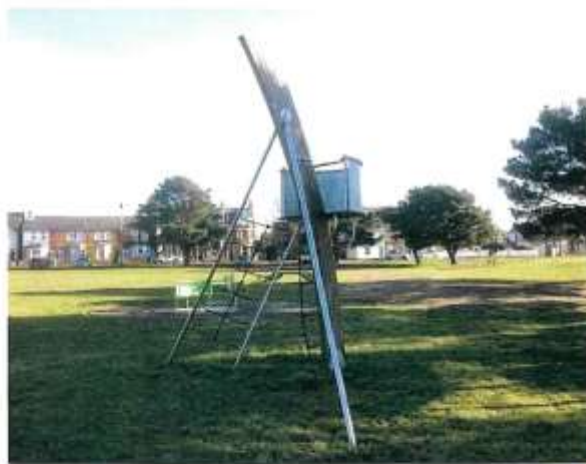
# Climber - Crow's Nest

Fixtures loose or missing.

Various.

Exposed metal rope core(s).

Monitor for sharp strands breaking free, particularly at stress points.

Tighten.

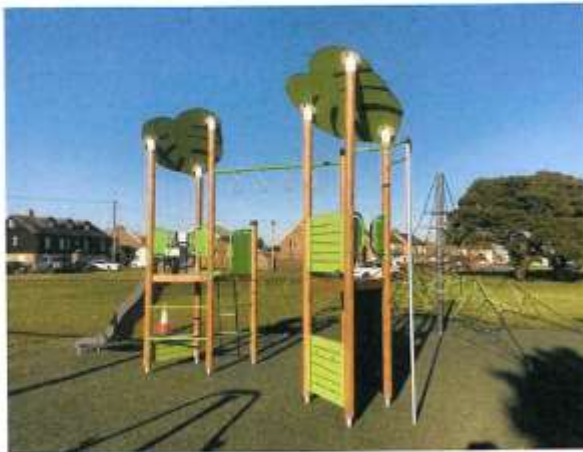
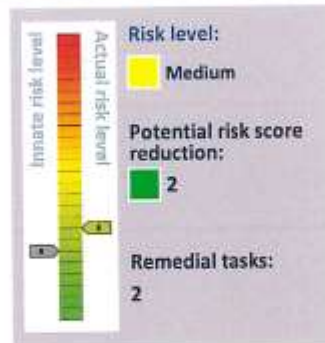
## Multiplay - Junior

\* The item is not compliant with the requirements of the relevant standards. The surfacing meets with the requirements of the relevant standards.

<p><b>Description</b></p> <p>✍ Fixtures loose or missing.</p> <p><b>Tasks</b></p> <p>✍ Tighten.</p> <p><b>Note</b></p> <p>✍ Two bolts found to be very loose. Ensure that all other fittings are properly tightened.</p>	<p><b>Risk level:</b></p> <p><span style="background-color: yellow; border: 1px solid black; padding: 2px;">Medium</span></p> <p><b>Risk score:</b></p> <p><span style="background-color: yellow; border: 1px solid black; padding: 2px;">8</span></p>
--	--

<p><b>Description</b></p> <p>✍ Finger entrapment.</p> <p><b>Tasks</b></p> <p>✍ Eliminate the entrapment.</p> <p><b>Note</b></p> <p>✍ Top of the climbing wall. Modify the positions of the brackets to prevent the insertion of the 8 mm diameter finger rod.</p>	<p><b>Risk level:</b></p> <p><span style="background-color: lightgreen; border: 1px solid black; padding: 2px;">Low</span></p> <p><b>Risk score:</b></p> <p><span style="background-color: green; border: 1px solid black; padding: 2px;">4</span></p>
---	--

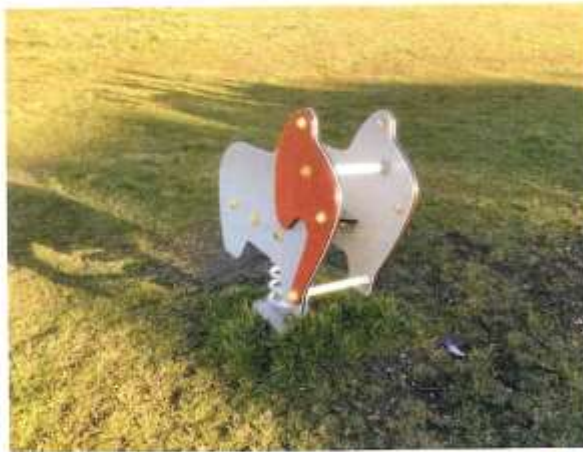
## Rocker - Elephant

Cap missing.

Fixtures loose or missing.

Unusual movement in bracket. Dismantle, investigate, repair as appropriate.

Item is bent.

Replace.

Repair.
