The Rype Swing Fixing Failures

Report by David Yearley

Site: The Rype Play Area
Owner: Lydd Town Council
Date of Report: 26th February 2025

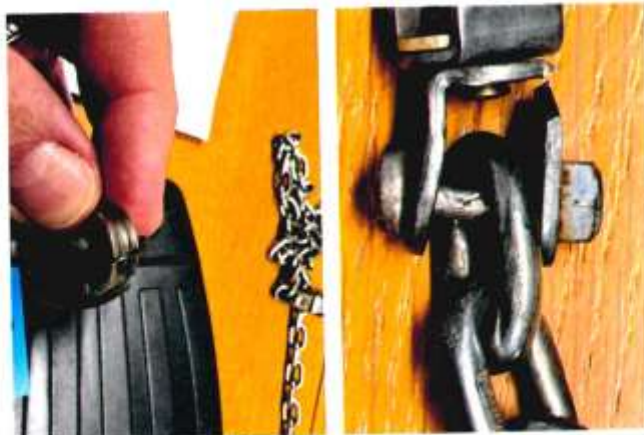
Photograph 1. Photograph 2.

2.2 The fixings in Photograph 1 show significant wear and a snapping of the metal, accompanied by a twisting in the metal at and around the point of failure.

2.3 The fixing in Photograph 2 shows a clean snap of the metal at the point of failure and a bending of the fixings opposite the point of failure.

5.1 There are two types of fixing which have failed.

5.2 Photograph 1 shows one type, which is used to connect the swing seat to the hanging chains on junior (flat) swing seats. Two failures of this type of connector have occurred at The Rype.

5.3 Photograph 2 shows the second type, which is used to connect the chains on a Tango seat (dual use adult and toddler seat) to the top fixings. One failure of this has been noted at The Rype.

5.10 My study of the exact point of failure on the fixing, and the condition of the top bar where it is clear that the chains are being wrapped around it, and the condition of the swing hangers leads me to conclude that the fixings in Photograph 1 have failed as a result of deliberate and concerted efforts to induce failure by users.

5.17 My study of the failed fixing in Photograph 2 and the swing frame, top bar and hangers from on which it was installed are inconclusive. There is no obvious undue wear to any of the components, although I did note some bending of the fixing on the opposite side to the point of failure, which in my opinion was likely caused at the moment of failure when the weight of the assembly and users upon it caused it to bend, given that it was designed to share the load with both sides of the fixing. On balance, it is my opinion that this failure has occurred as a result of overloading by a deliberate and concerted effort to induce failure by users.

5.19 In conclusion, it is my opinion that the fixings in Photograph 1 were caused by misuse, and it is likely that the fixing in Photograph 2 was caused by misuse.

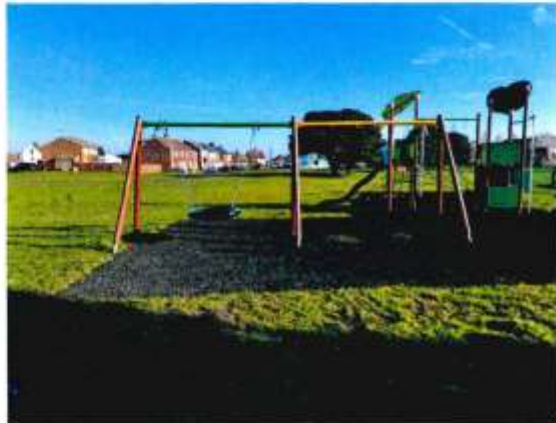
Photograph 3.

5.4 Photograph 3 shows the swing frame on which the fixings in Photograph 1 were installed at the time of failure.

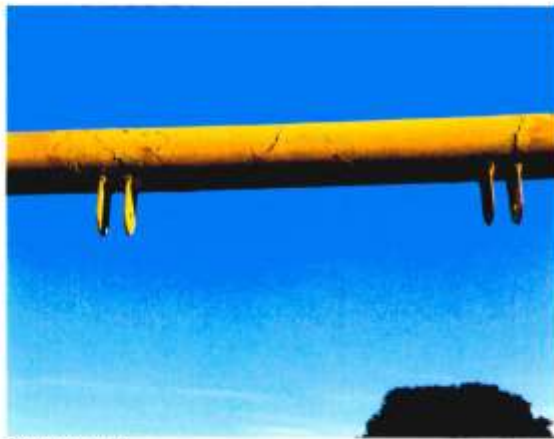
Photograph 4.

5.5. Photograph 4 shows the top bar of the swing frame on which the fixings in Photograph 1 were installed.

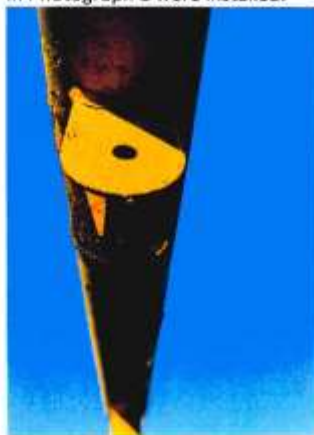
Photograph 5.

5.6 Photograph 5 shows the hangers on the top bar of the swing frame on which the fixings in Photograph 1 were installed.

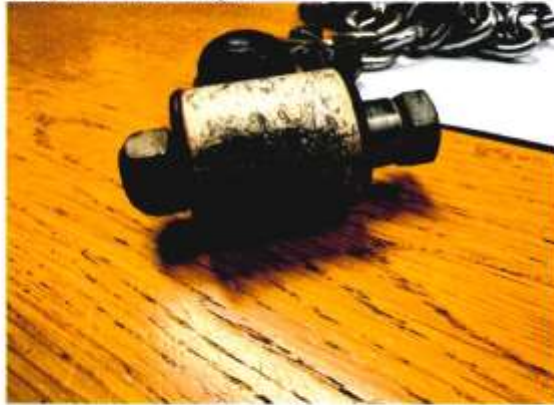
Photograph 6.

5.7 Photograph 6 shows deep scoring on the top of the pivot bearing which connected the swing chains to the hangers.

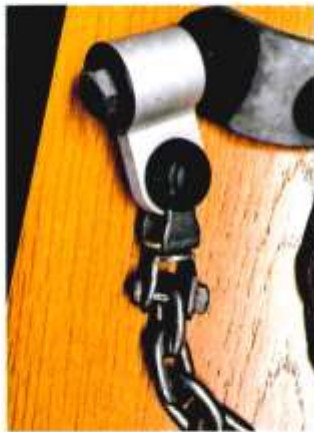
Photograph 7.

5.12 Photograph 7 shows the failed second fixing in a wider context than Photograph 2. The top bearing pivot can be seen to be free of any scoring which was present at photograph 6.

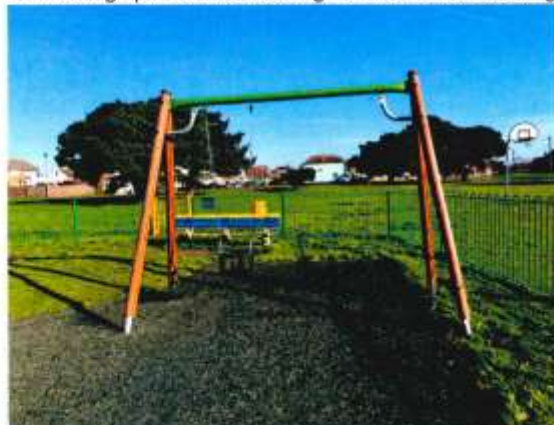
Photograph 8.

5.13 Photograph 8 shows the swing frame on which the fixing in Photograph 2 was installed.

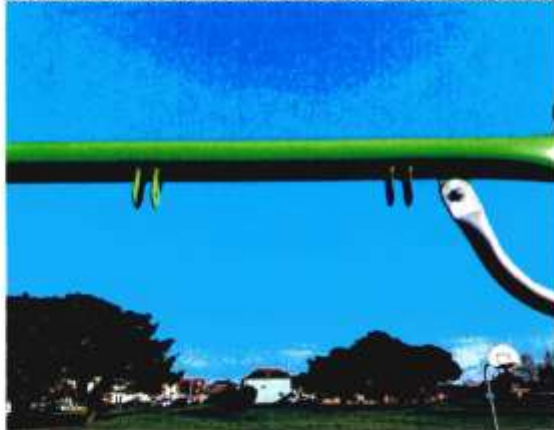
Photograph 9.

5.14 Photograph 9 shows the top bar of the swing frame on which the fixing in Photograph 2 was installed. No significant damage can be seen to the top bar's paint.

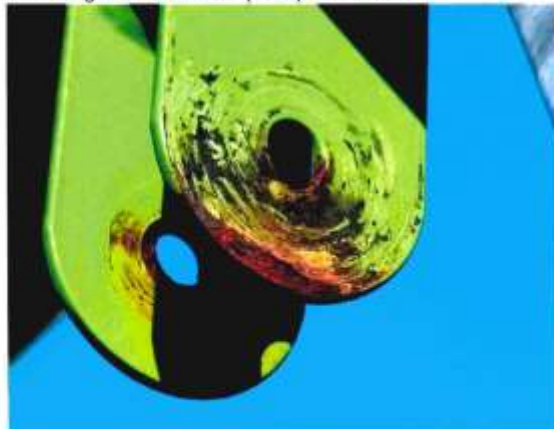
Photograph 10.

5.15 Photograph 10 shows the hangers on the top bar of the swing frame on which the fixing in Photograph 2 was installed. Some elongation of the pivot hole can be seen, indicating wear where the pivot pin sits on it.

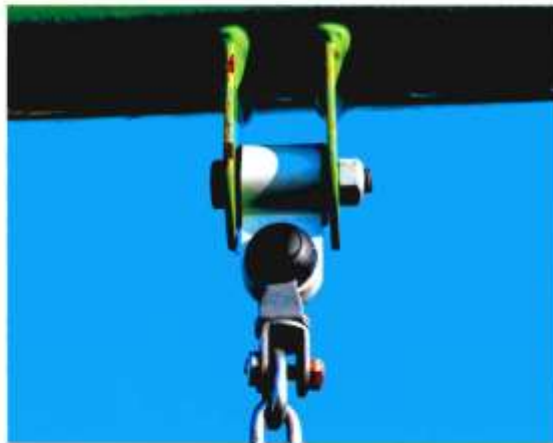
5.16 Photograph 11 shows an intact and installed swing top fixing, including the type in Photograph 2, on the same swing frame. This holds the existing cradle (toddler) seat.
