## **Arboricultural Condition Report**

Memorial Garden  
Park Street  
Lydd  
Kent

The Rype  
Lydd  
Kent

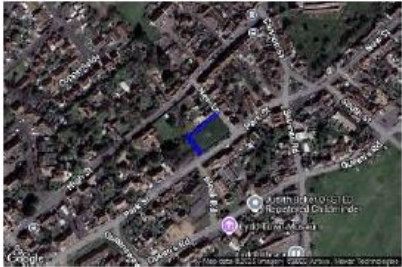
| Group ID #1 | |

| Group ID #1 | |
|---|---|
| Comments: | Group of twenty-one Lime trees that are subject to cyclical pollarding. The last cycle was undertaken in 2024. All trees present are considered to pose a broadly acceptable risk to users of the site and neighbouring properties. |

| Group ID #1 | |
|---|---|
| Recommendations: | Continue with cyclical (three yearly) pollarding. |

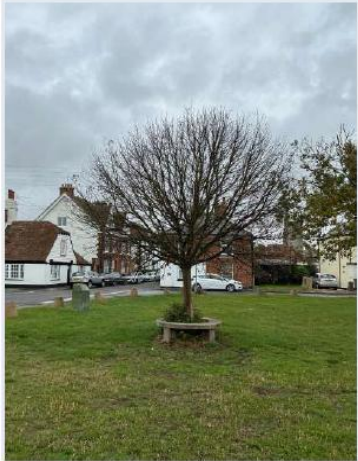
| Holm oak Tree ID #1<br>10 Skinner Road | |

The tree has died as a result of its bark being stripped from its main stem.

Remove the memorial bench; Fell the tree to ground level, grind out the stump and reinstate with topsoil and grass seed. Replant with a new tree (of whichever desired species) nearby and reinstall the memorial bench. The new tree should ideally be planted with a minimum stem girth of 12/14cm and be regularly watered and its base kept free of weed and grass growth for the first three years in order to ensure its establishment.

Priority 2 - 3 months

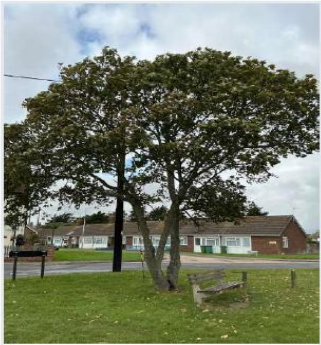
| Sycamore Tree ID #2<br>30 Skinner Road | |

Two minor cavities are evident at the base of this twin-stem tree on the eastern side measuring 200mm x 125mm and extending inwards by 25mm with minor decay evident. The tree is currently considered to pose an acceptable risk to users of the adjacent memorial bench, users of The Rype and adjacent highway.

None.

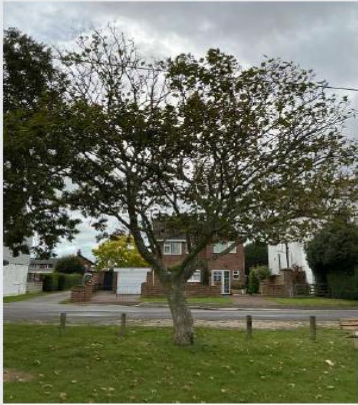
| Sycamore Tree ID #3<br>81 Manor Road | |
|---|---|
| Comments: | Early signs of bark delaminating at base of tree on the north side. Large diameter (>50mm) dead wood scattered throughout canopy. The tree is currently considered to pose an acceptable risk to users of The Rype, adjacent memorial bench And highway. No change since the 2024 inspection report. |

| Sycamore Tree ID #3<br>81 Manor Road | |
|---|---|
| Recommendations: | Prune out all large diameter deadwood. |
| Priority: | Priority 2 - 3 months |

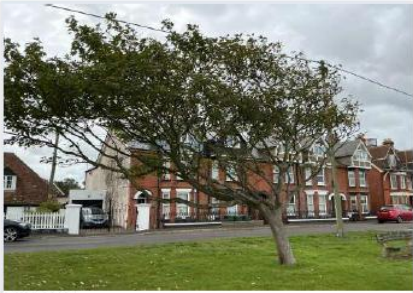
| Sycamore Tree ID #4<br>55 Manor Road | |
|---|---|
| Comments: | A cavity measuring 250mm x 125mm is evident at the base of tree on the northern side. The cavity extends inwards by 300mm; the tree has a diameter at base of 330mm. Minor decay is evident within the cavity. The tree has a small compact canopy that is biased to the north and does not exert too much strain on the overall structure and as such the tree is currently considered to pose an acceptable Risk to users of The Rype. |

| Sycamore Tree ID #4<br>55 Manor Road | |
|---|---|
| Recommendations: | None. |

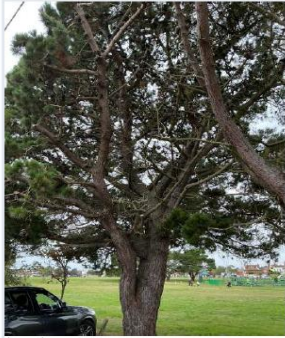
| Monterey Pine Tree ID #5<br>23 Manor Road | |

| Monterey Pine Tree ID #5<br>23 Manor Road | |
|---|---|
| Comments: A large concentration of large diameter (>50mm) deadwood is evident throughout the mid canopy of the tree on the south eastern side some of which has snapped out and is hung up within the canopy. | |

| Monterey Pine Tree ID #5<br>23 Manor Road | |
|---|---|
| Recommendations: Prune out all large diameter deadwood. | image.jpg<br>10/09/2025 |
| Priority: Priority 2 - 3 months | |

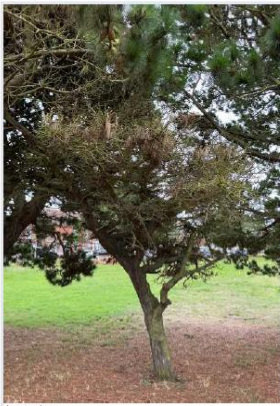
| Monterey Pine Tree ID #6<br>13 Manor Road | |

| Monterey Pine Tree ID #6<br>13 Manor Road | |
|---|---|
| Comments: This small Pine tree has died. | |

| Monterey Pine Tree ID #6<br>13 Manor Road | |
|---|---|
| Recommendations: Fell to ground level; grind out the stump and reinstate with topsoil and grass seed. | image.jpg<br>10/09/2025 |
| Priority: Priority 3 - 6 months | |

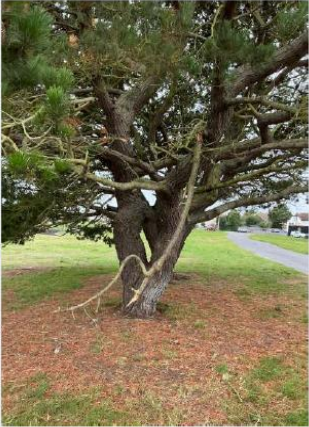
Monterey Pine Tree ID #7

| Tree Details | |
|---|---|
| Comments: | Snapped large diameter (>50mm) branch hanging down at children's eye level on the eastern side of the canopy. |

| Tree Details | |
|---|---|
| Recommendations: | Prune out snapped branch. |
| Priority: | Priority 2 - 3 months |

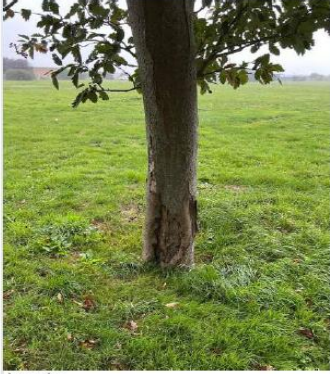
| Swedish whitebeam Tree ID #1 | |
|---|---|
| Comments: | Wound at base on north side of main stem measuring 600mm x 300mm with minor decay evident. Good wound wood formation is evident around the circumference of the wound. The tree is currently considered to pose an acceptable risk to Users of the site. |

| Swedish whitebeam Tree ID #1 | |
|---|---|
| Recommendations: | None. |

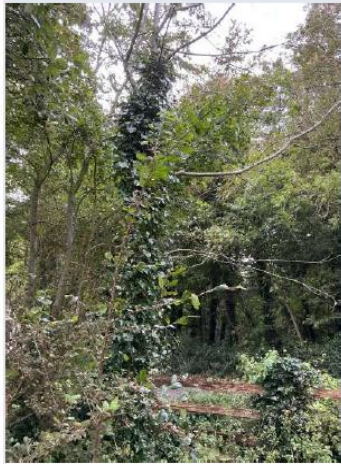
| English elm Tree ID #2 | |

| English elm Tree ID #2 | |
|---|---|
| Comments: | Dead roadside tree. |

| English elm Tree ID #2 | |
|---|---|
| Recommendations: | Fell to ground level. |
| Priority: | Priority 3 - 6 months |

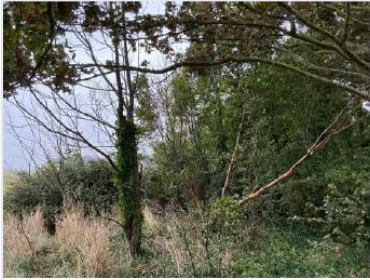
English elm Tree ID #3

| Tree Details | |
|---|---|
| Comments: | Group of small dead Elm trees that are now beginning to collapse. |

| Tree Details | |
|---|---|
| Recommendations: | Fell all dead Stems to ground level. |
| Priority: | Priority 2 - 3 months |
