## Safety Inspection Report

### The Rype

Lydd Town Council

22 August 2023

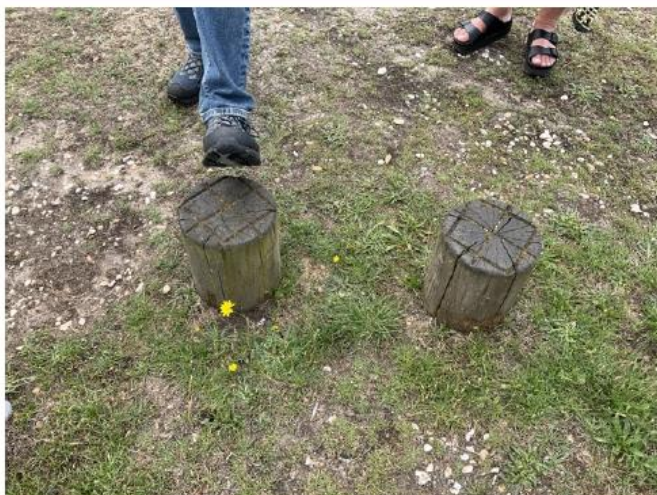
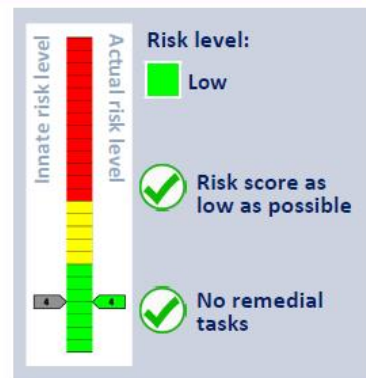
## Stepping Logs (Groups)

The item and its surfacing (where applicable) meet with the requirements of the relevant standards.

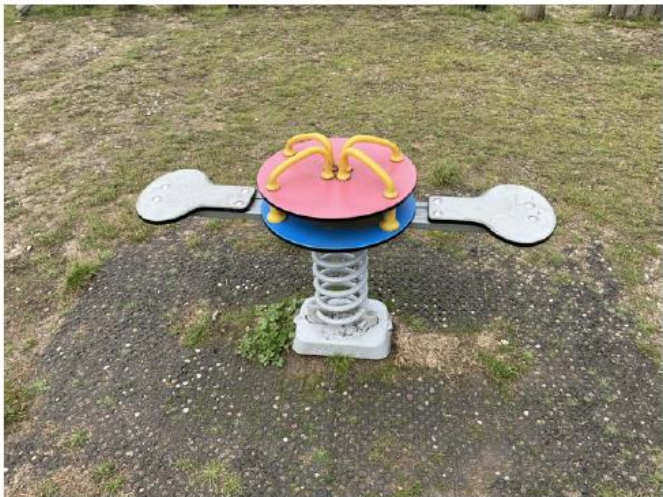
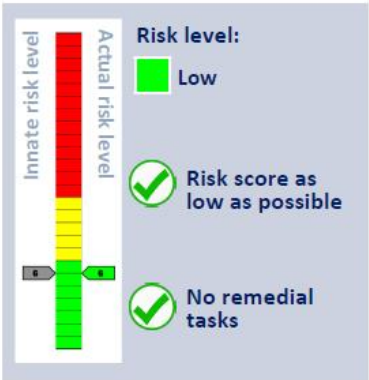
Rocker - Seesaw

Cap missing.

Replace.

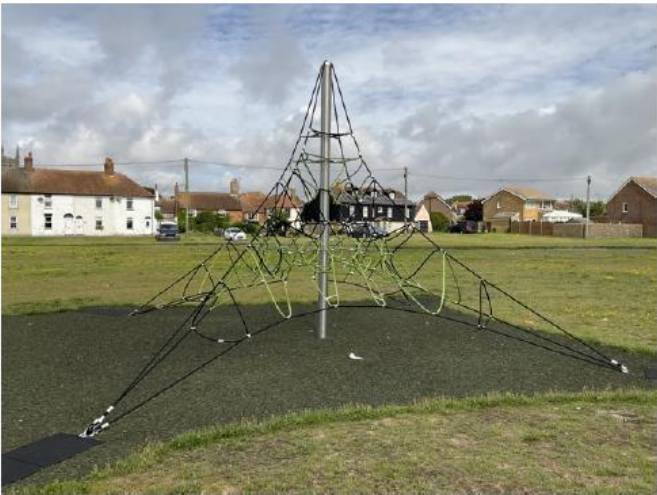
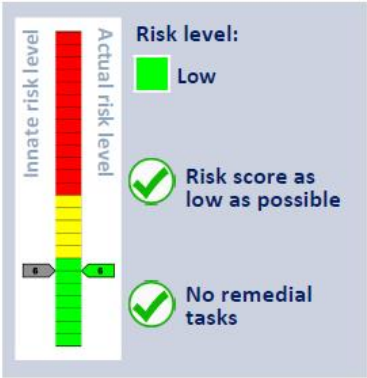
Space Net - Central Post

EN 1176-11:2014, EN 1176-1:2017  
The item and its surfacing (where applicable) meet with the requirements of the relevant standards.

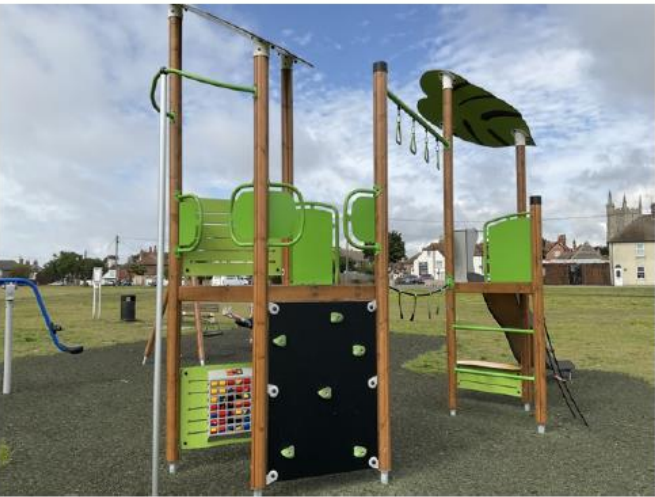
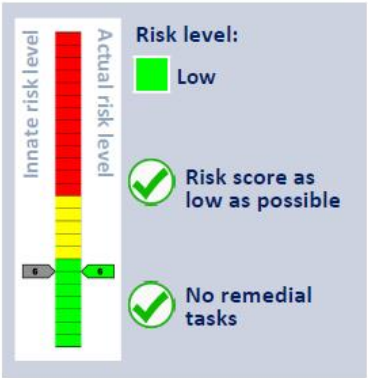
Multiplay

EN 1176-1:2017  
The item and its surfacing (where applicable) meet with the requirements of the relevant standards.
