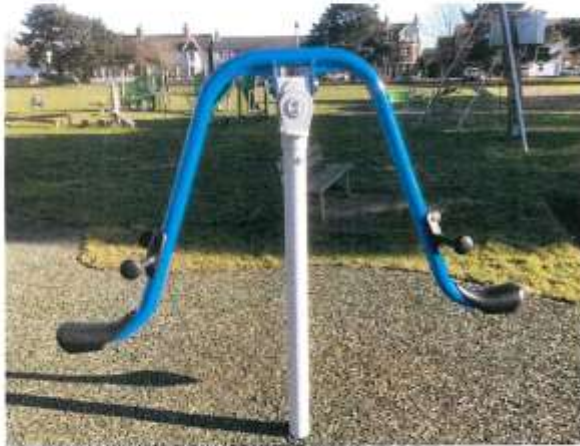
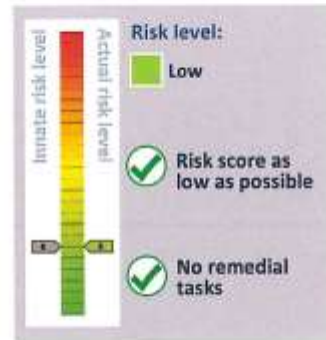
## Rocker - Sweeping Seesaw - Gyro Spiral

The item and its surfacing (where applicable) meet with the requirements of the relevant standards.

Surface: Rubber - Mulch - Bonded at a depth of 40 mm

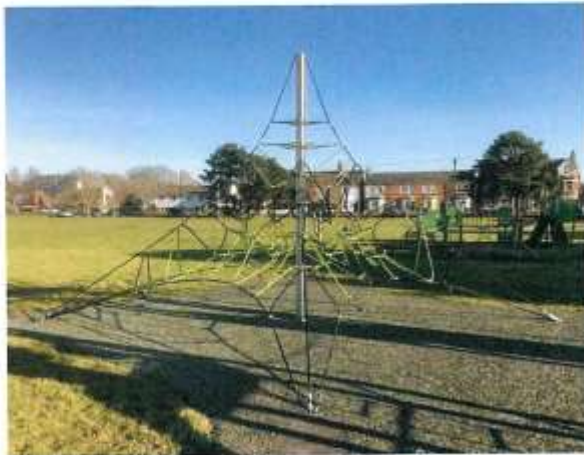
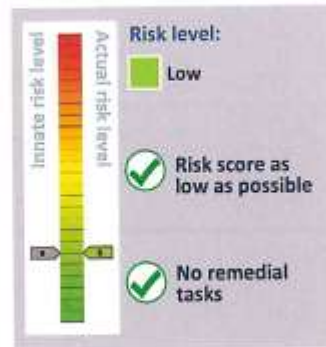
## Space Net - Central Post

The item and its surfacing (where applicable) meet with the requirements of the relevant standards.

Surface: Rubber - Mulch - Bonded at a depth of 40 mm

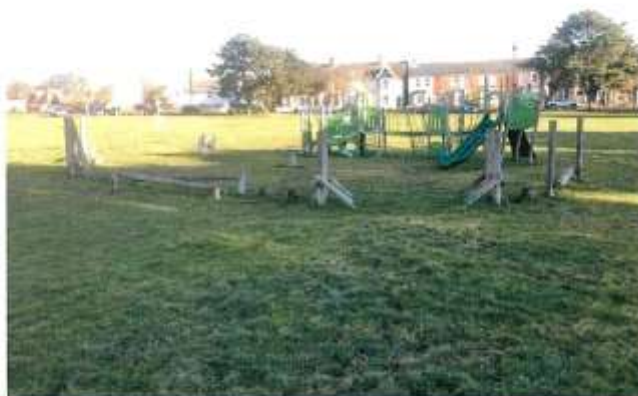
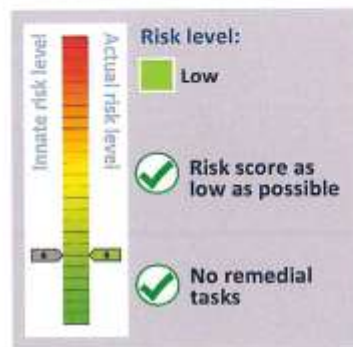
# Agility Trail

Surface: Grass

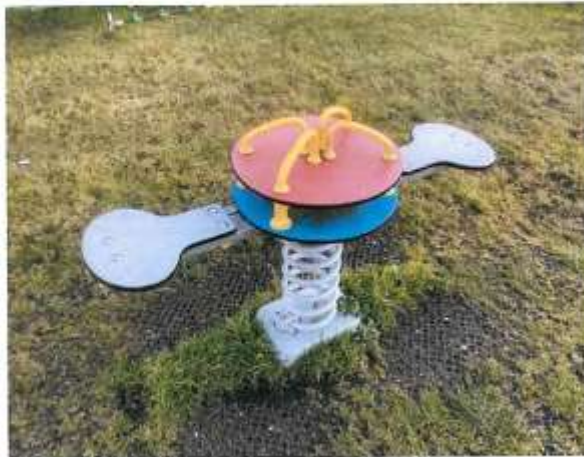
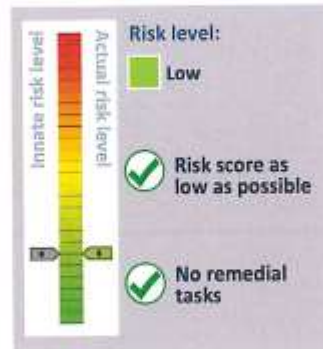
## Rocker - Seesaw

Surface: Grass Matting at a depth of 16 mm

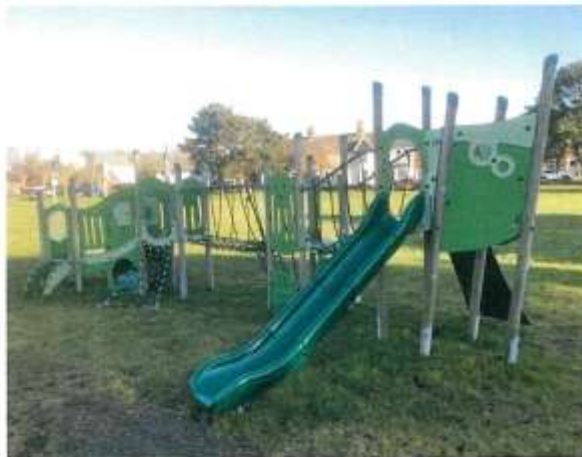
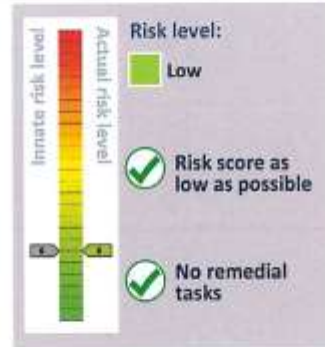
## Multiplay - Toddler

EN 1176-1:2017  
The item and its surfacing (where applicable) meet with the requirements of the relevant standards.
