## **Arboricultural Condition Report**

Memorial Garden  
Park Street  
Lydd  
Kent

The Rype  
Lydd  
Kent

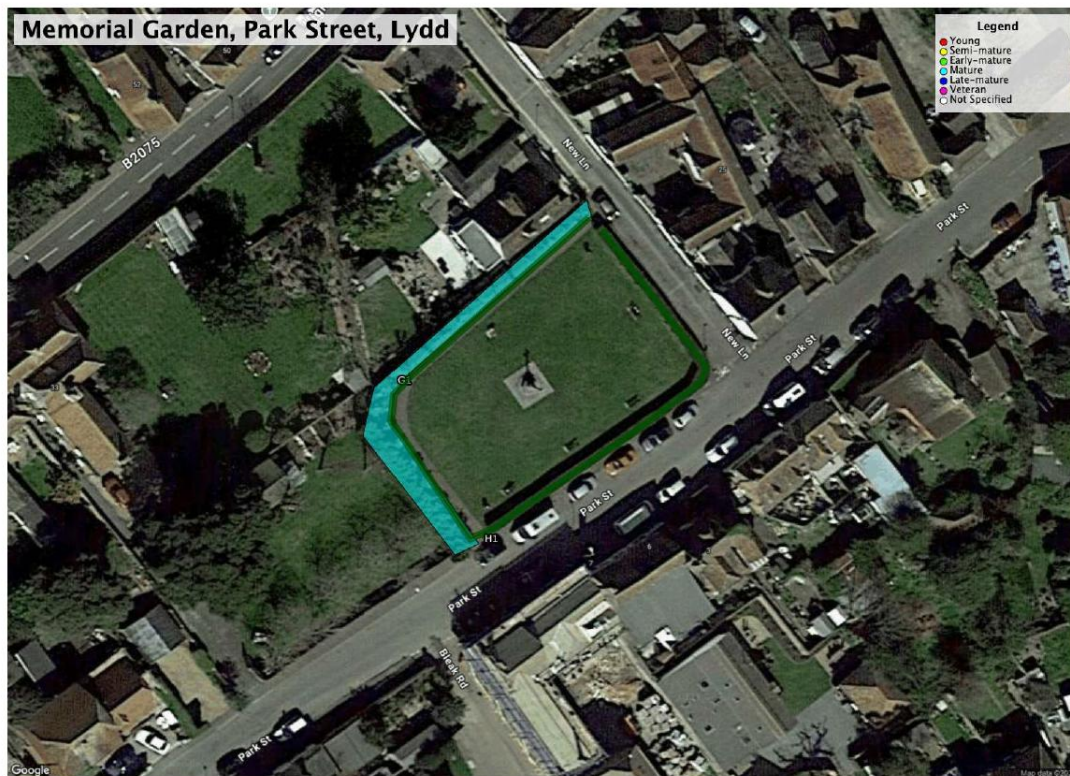
| Hedge ID #1 | | Photos Street View Map View | |
|---|---|---|--|
| Comments: | The Yew hedge extends around all boundaries of the Memorial Garden. The hedge is a close clipped formal feature of the garden. There is currently no sound arboricultural or horticultural justification for hard pruning the hedgerow to form a more compact hedgerow as this would result in the exposure of bare wood, which would take a significant amount of time to green back up as demonstrated within the garden where a section was hard pruned for a memorial bench some years ago. | | |

| Hedge ID #1 | | Photos Street View Map View | |
|---|---|---|--|
| Recommendations: | None. | | |
