Safety Inspection Report

Annual Inspection

Tennis Courts

Lydd Town Council

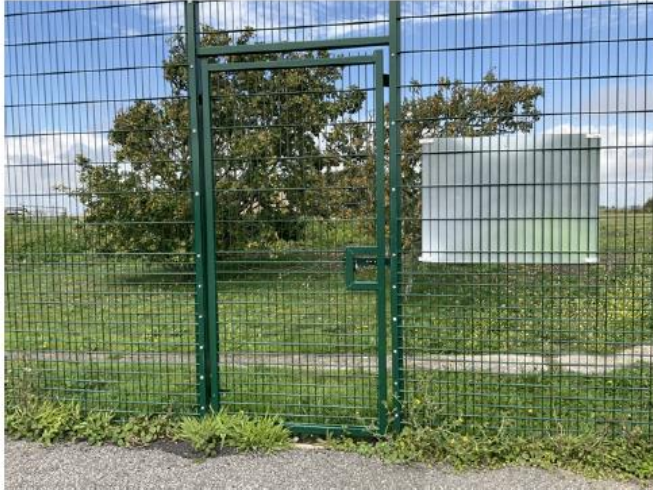
Gates & Fencing

Trip points on the surface.

Low

7

Make level.

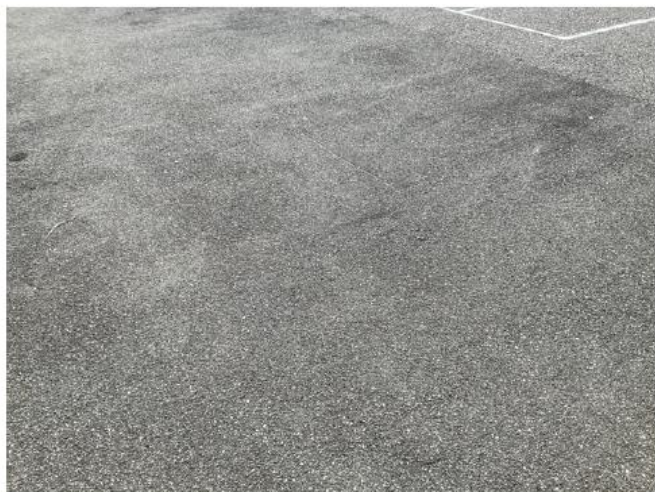
General Surface

Item has some parts missing.

Very low

2

Read the notes for further action.

Replace with tamper proof fittings.

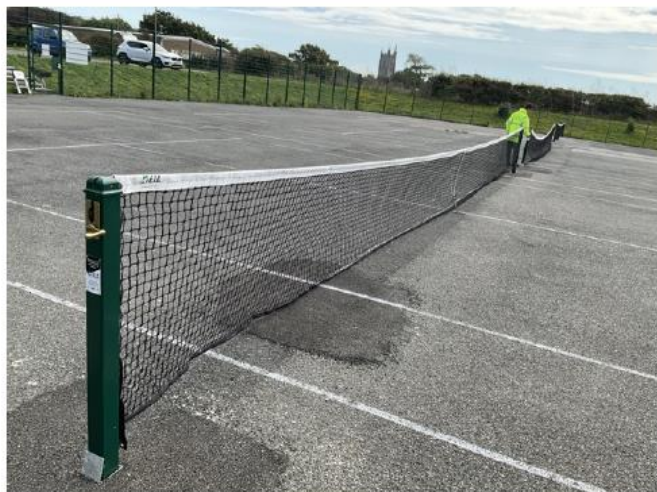
Tennis Nets x 3

There are no issues with the nets themselves. Temporary surface line markings have been painted. These lines are close, but not quite the correct dimensions. This will not affect casual / recreational play, but could preclude professional / competitive play. Ensure the correct dimensions are achieved when permanent markings are painted in the future.

Very low

3
